ANNUAL REPORT FOR 2006

Third Street Bridge Mitigation Site
New Hanover County
TIP No. U-0092A

Natural Environment Unit & Roadside Environmental Unit
North Carolina Department of Transportation
December 2006

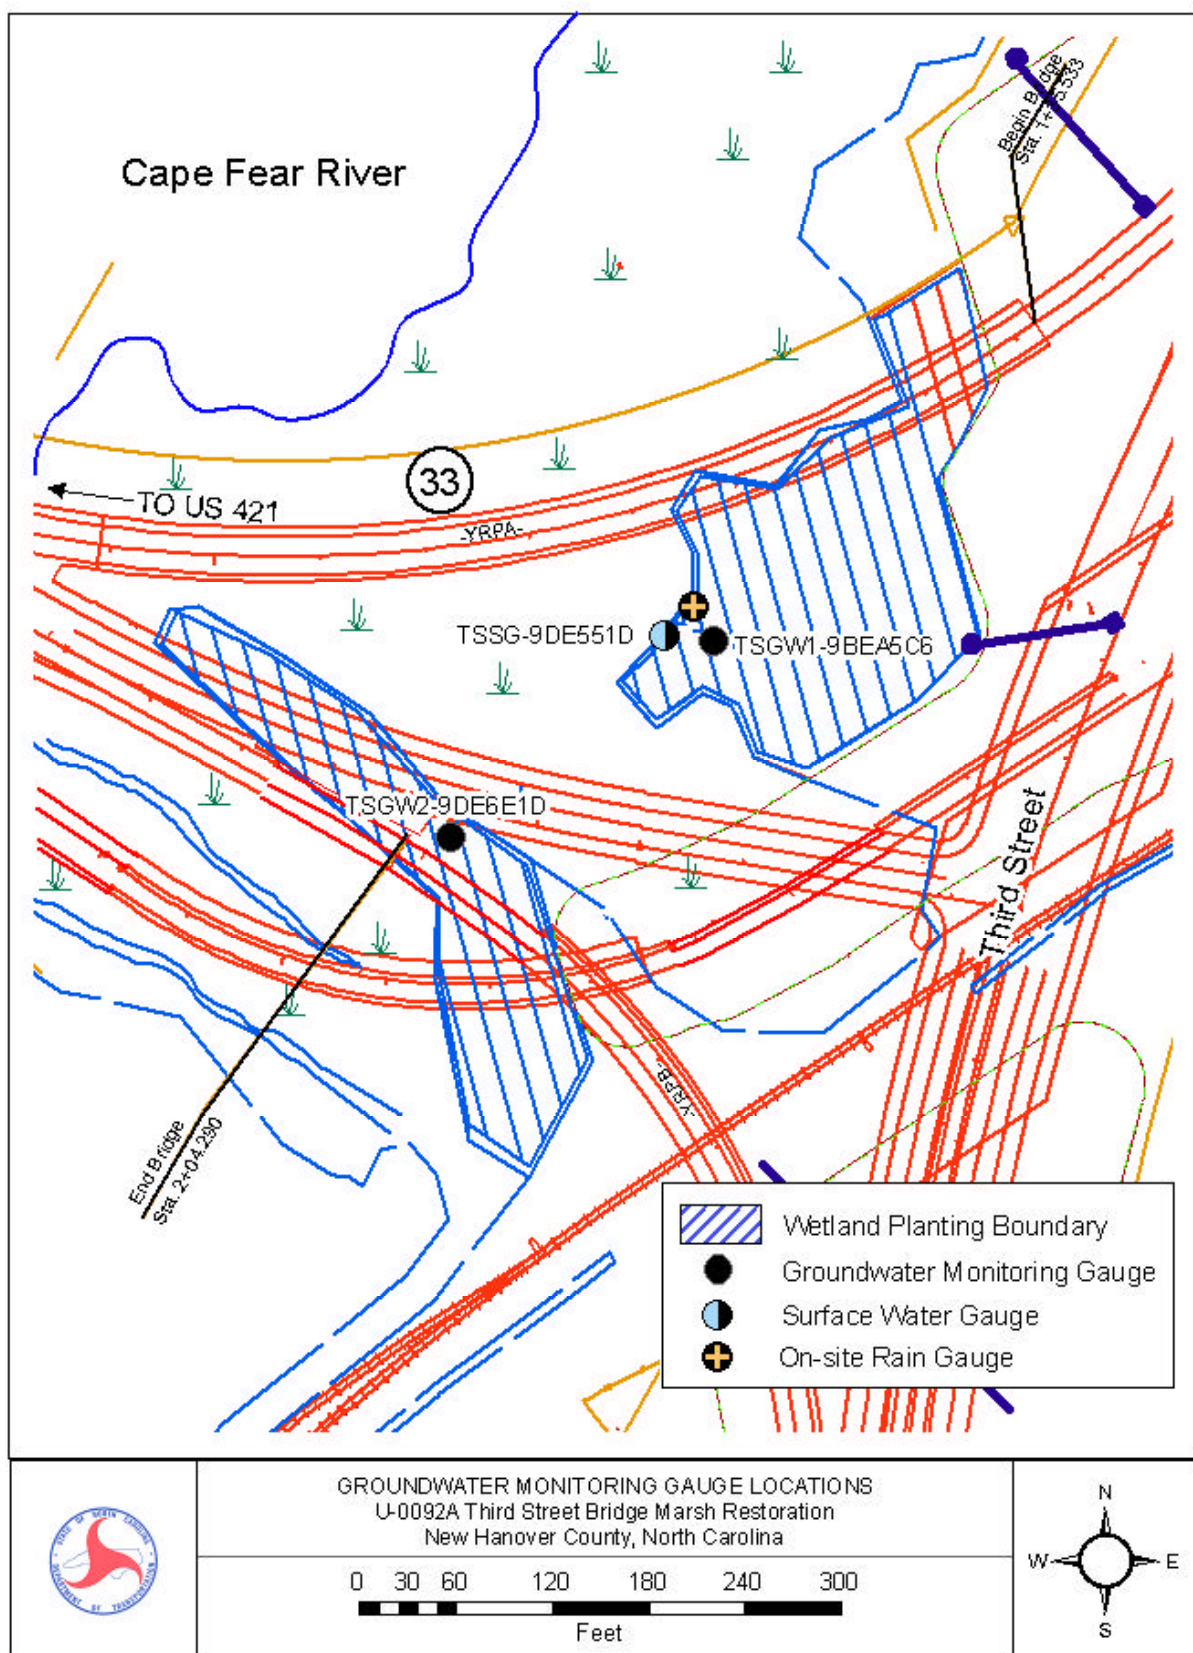
Figure 2. Monitoring Gauge Location Map

Two groundwater monitoring gauges and one surface water monitoring gauge were installed within the sites' restoration area in May 2006 (Figure 2). The groundwater gauges record groundwater level once per day and the surface water gauge records surface water readings every three hours. A rain gauge is also located on the site to assist in comparison of the rainfall data (supplied by the NC State Climate Office) from an official weather station in Wilmington. Monitoring data for 2006 represents the first year of hydrologic monitoring for the site.

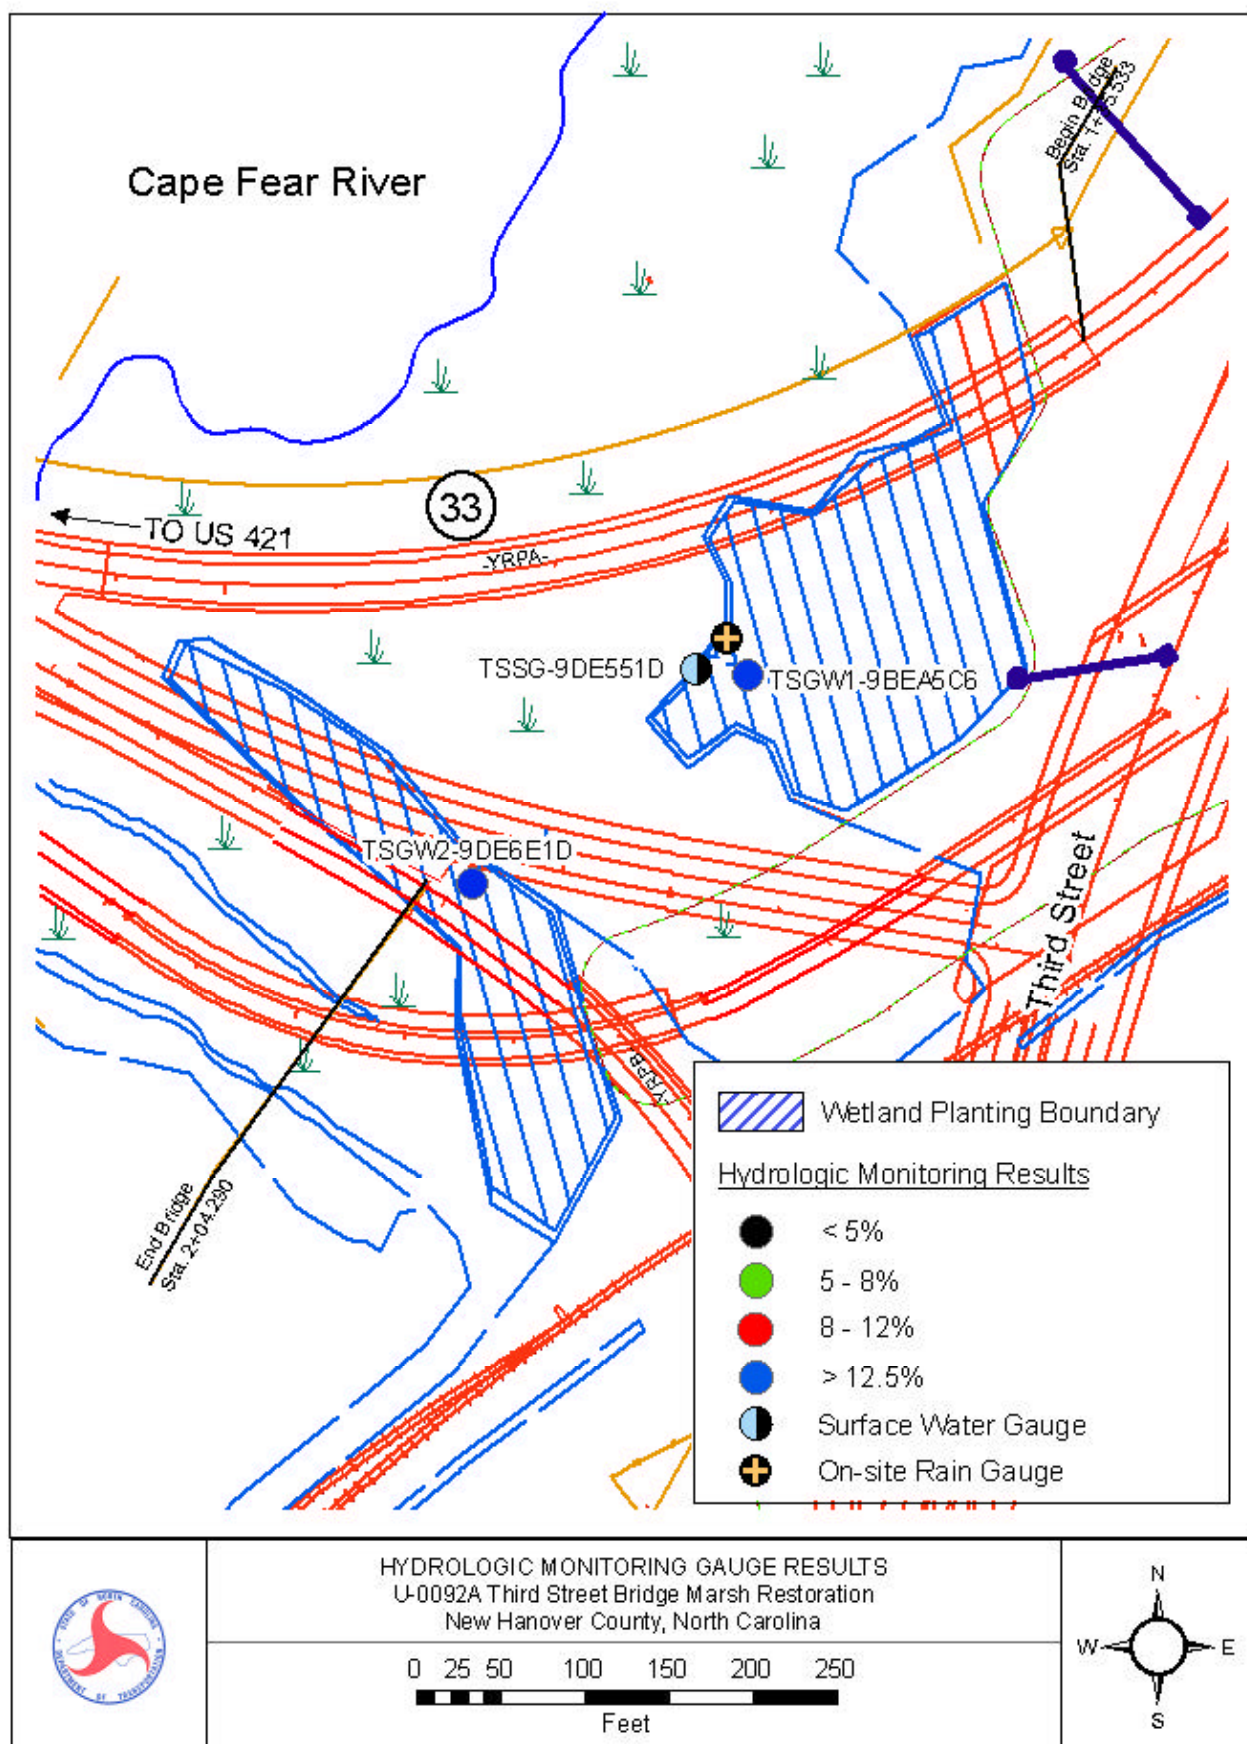
Figure 3. Hydrologic Monitoring Results Map

The maximum number of consecutive days that saturation occurred within 12 inches of the ground surface was determined for each groundwater monitoring gauge. This number was converted into a percentage of the 271-day growing season (February 27 – November 26). Table 1 provides the 2006 hydrologic results; Figure 3 is a graphical representation of these results. Appendix A includes graphs of the data recorded at each groundwater and surface water gauge. Daily rainfall events recorded at the official weather station in Wilmington are included on each of the groundwater gauge plots.

Monitoring Gauge	< 5%	5-8%	8-12%	> 12.5%	Actual %
TS-GW1				X	13.2
TS-GW2				X	29.4

Both groundwater monitoring gauges indicated that the site met the jurisdictional criteria for wetland hydrology. The surface water gauge also showed periods of inundation during the 2006 monitoring year.

The 2006-year represents the first year of hydrologic monitoring for the Third Street Bridge Mitigation Site. Both groundwater monitoring gauges indicated that the site met the jurisdictional criteria for wetland hydrology above the required 12.5% of the growing season. The surface water gauge also showed periods of inundation throughout the monitoring year.

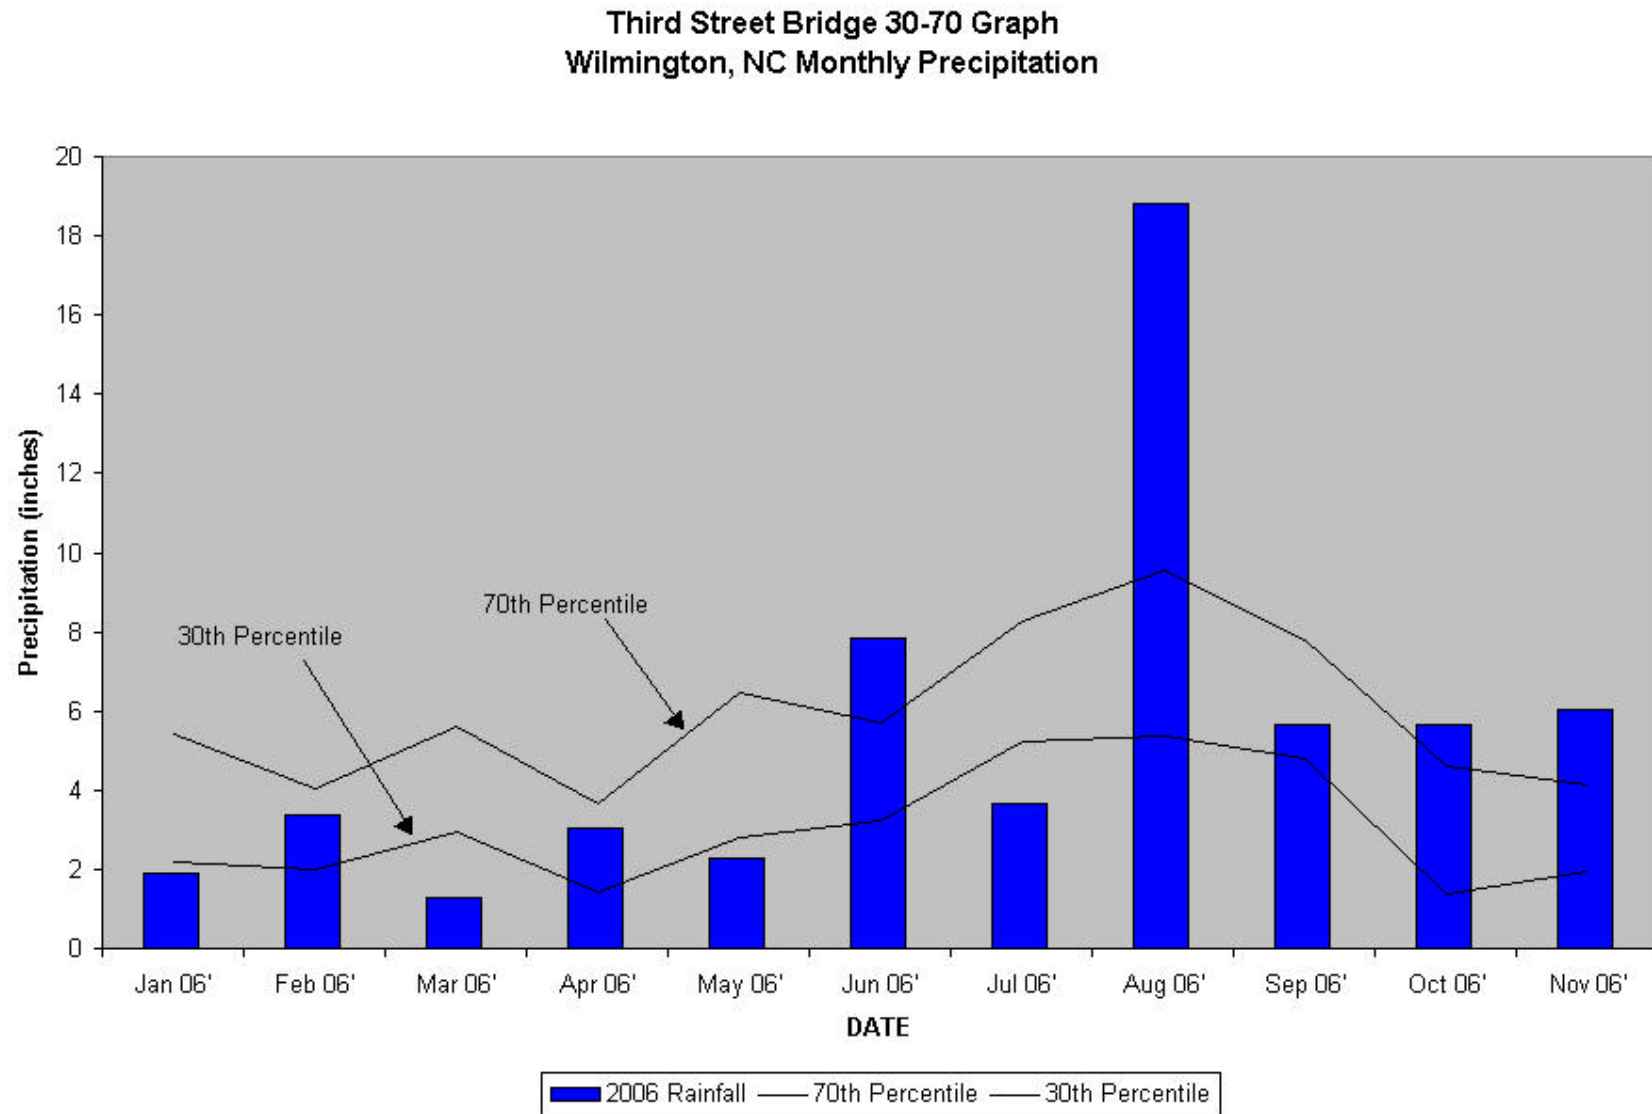
Figure 4. 30-70 Percentile Graph, Wilmington, NC

Figure 4 is a comparison of the 2006 monthly rainfall to the historical precipitation (collected between 1976 and 2006) for Wilmington, North Carolina. This comparison gives an indication of how 2006 relates to historical data in terms of climate conditions. The NC State Climate Office provided all local rainfall information.

This graph is used to indicate the general precipitation conditions for the surrounding area. Overall, 2006 exhibited normal rainfall. The data obtained for the 2006-year indicates that rainfall in June, August, October and November were above normal. The months of January, March, May and July tend to be on the low side of normal. Rainfall for the months of February, April and September were normal.
